Manhole Inspection Summary

Manhole # S21II_006MH

Insp Date: **6/25/07 8:58 AM**

Location Address: **1811 BRUCE ST** Cross Street: **WESTWOOD AVE**

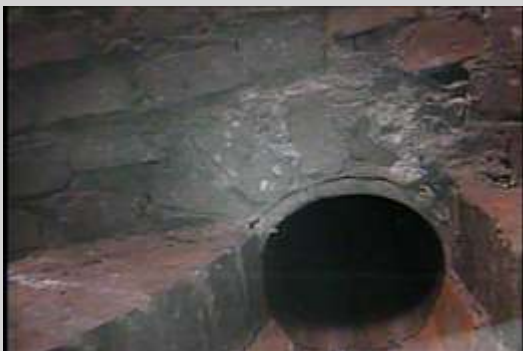
3 O'Clock Inflow

8 in. Circular Gravity Sewer
Pipe In @ 3 O'Clock

Pipe Height: **8.4** (in.) Rod and Bar (Angled)
Pipe Material: **Clay** ☐ Pipe Lined
Invert Depth: **7.83** (ft.) Flow Characteristics: **Slow**
Deposits: ☒ None ☐ Mud ☐ Sludge ☐ Debris ☐ Grease
Silt Depth: (in.) Deposits Extent:
Infiltration: **None** Pipe Seal Cond: **Sound**

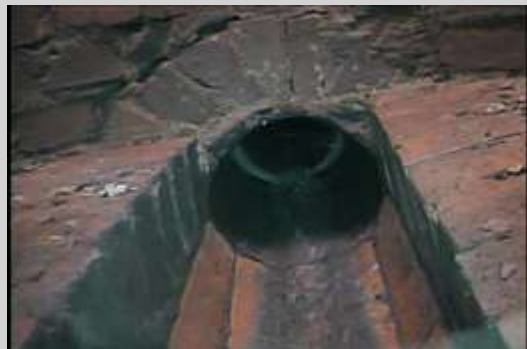
6 O'Clock Inflow

8 in. Circular Gravity Sewer
Pipe In @ 6 O'Clock

Infiltration: **None** Pipe Seal Cond: **Sound**
